**Flood Control Project Maintenance**  
**2009 Structure Summary Report**  
**Overall Unit and Item Ratings**

**Merced Irrigation District**

**Black Rascal Creek Drop Structure**

**Owens Creek Siphon Structure**

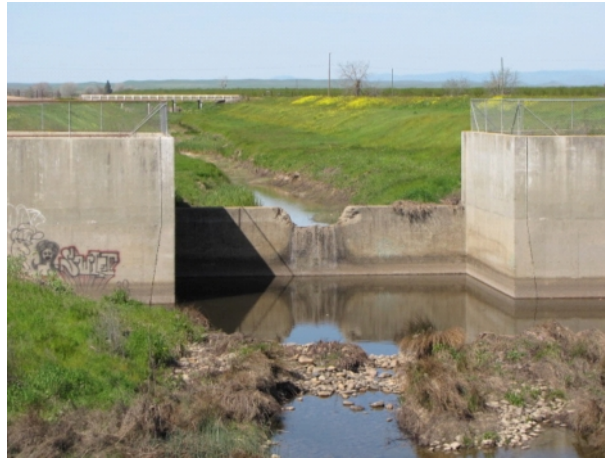
Levee Mile Report Line	1
Start Levee Mile	0.00
End Levee Mile	0.00
Location	
Category	Structures
Item	Photo Documentation
<p>This photo shows the structure from downstream across from Bear Creek. You can see the conditions of the structure from this view.</p> <p>phillips_20091203_19.jpg</p>

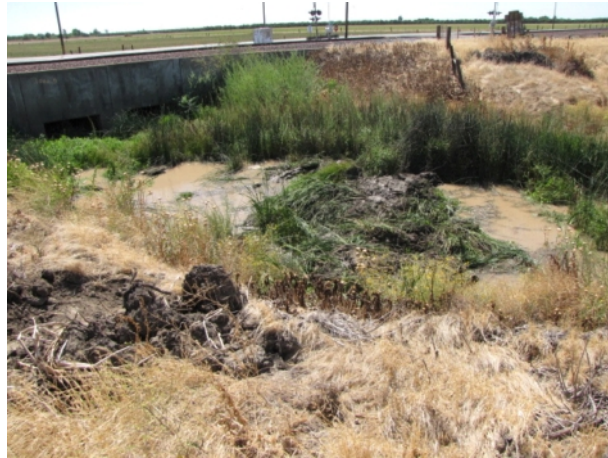
Levee Mile Report Line	1
Start Levee Mile	0.00
End Levee Mile	0.00
Location	Land Side
Category	Structures
Item	Photo Documentation
Photo of the owens drop structure from the inlet side. Vegetation and sediment present in channel.	
phillips_20090806_13.jpg

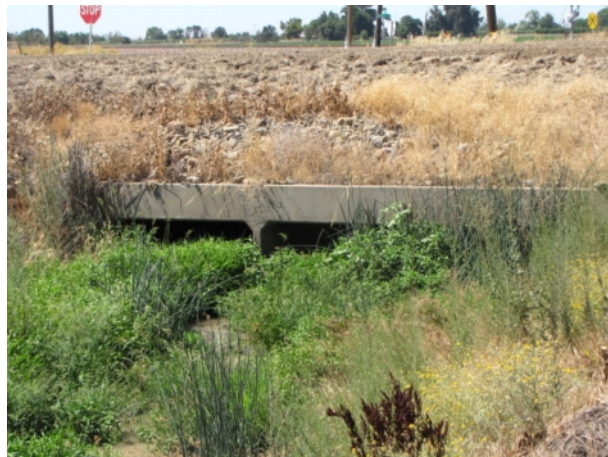
Levee Mile Report Line	2
Start Levee Mile	0.00
End Levee Mile	0.00
Location	Land Side
Category	Structures
Item	Vegetation & Obstructions
Photo of the outlet end of structure as it comes under Santa Fee (HWY 140). Veg present in channel	
phillips_20090806_8.jpg

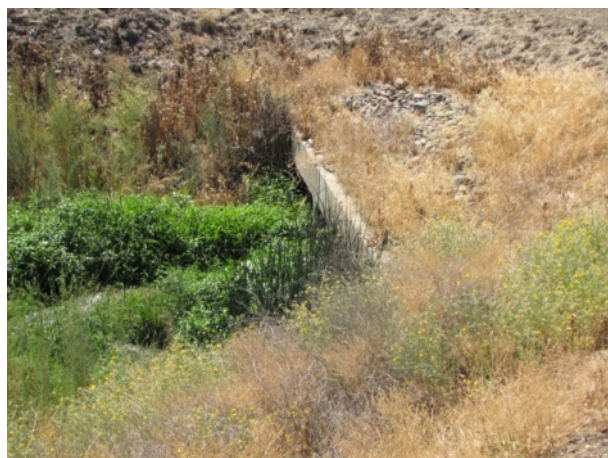
Levee Mile Report Line	2
Start Levee Mile	0.00
End Levee Mile	0.00
Location	Land Side
Category	Structures
Item	Vegetation & Obstructions
Another view of the outlet.	
phillips_20090806_9.jpg

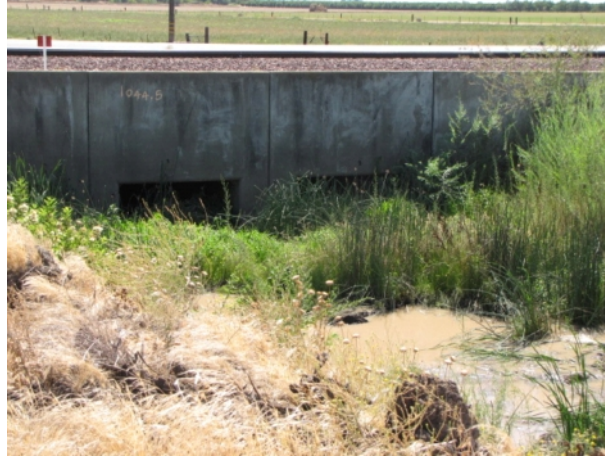
Levee Mile Report Line	3
Start Levee Mile	0.00
End Levee Mile	0.00
Location	Land Side
Category	Structures
Item	Shoaling / Sedimentation
This photo shows the sedement and growth at the inlet of structure.	
phillips_20090806_10.jpg
